**State of Louisiana
Department of Natural Resources
Coastal Restoration Division**

2007 Annual Inspection Report

Jonathan Davis Wetland Protection

State Project Number BA-20
Priority Project List 2

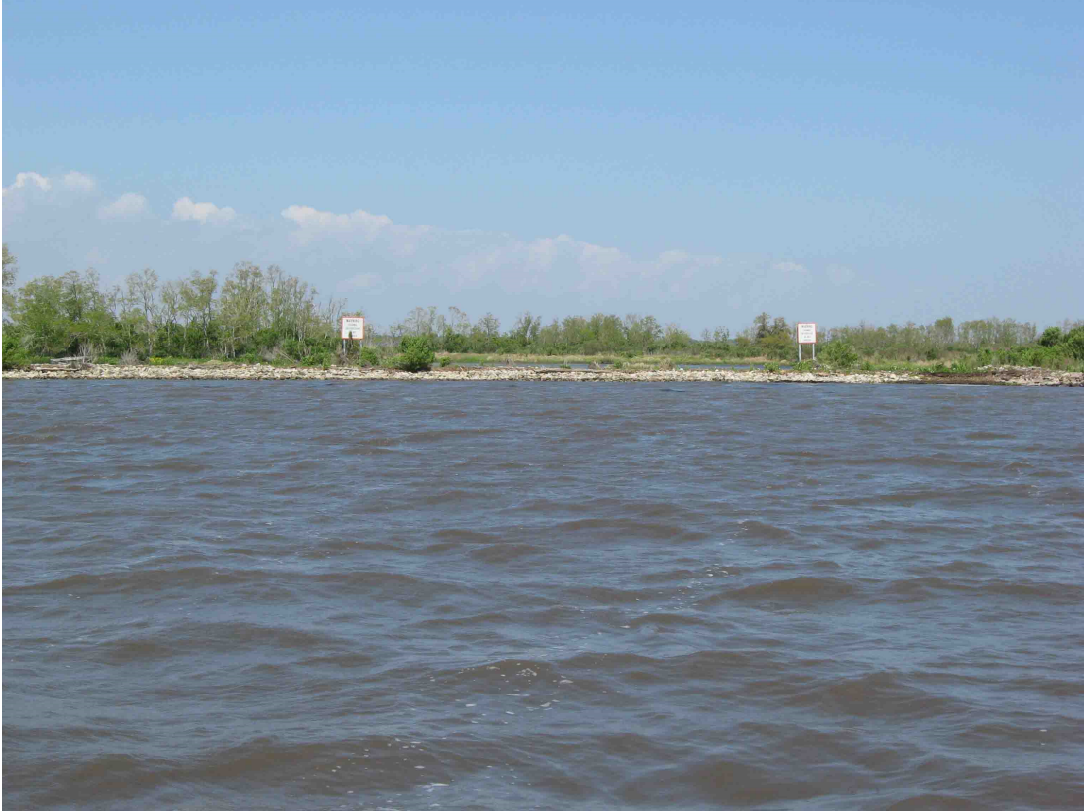
Photo #1 – Structure #12

The structure is in good condition. (Photo #1) There is some slight settling near the edge of the plug adjacent to the two signs. All of the signs and supports were in good condition. At this time there is no need for any maintenance work to be done at this structure.

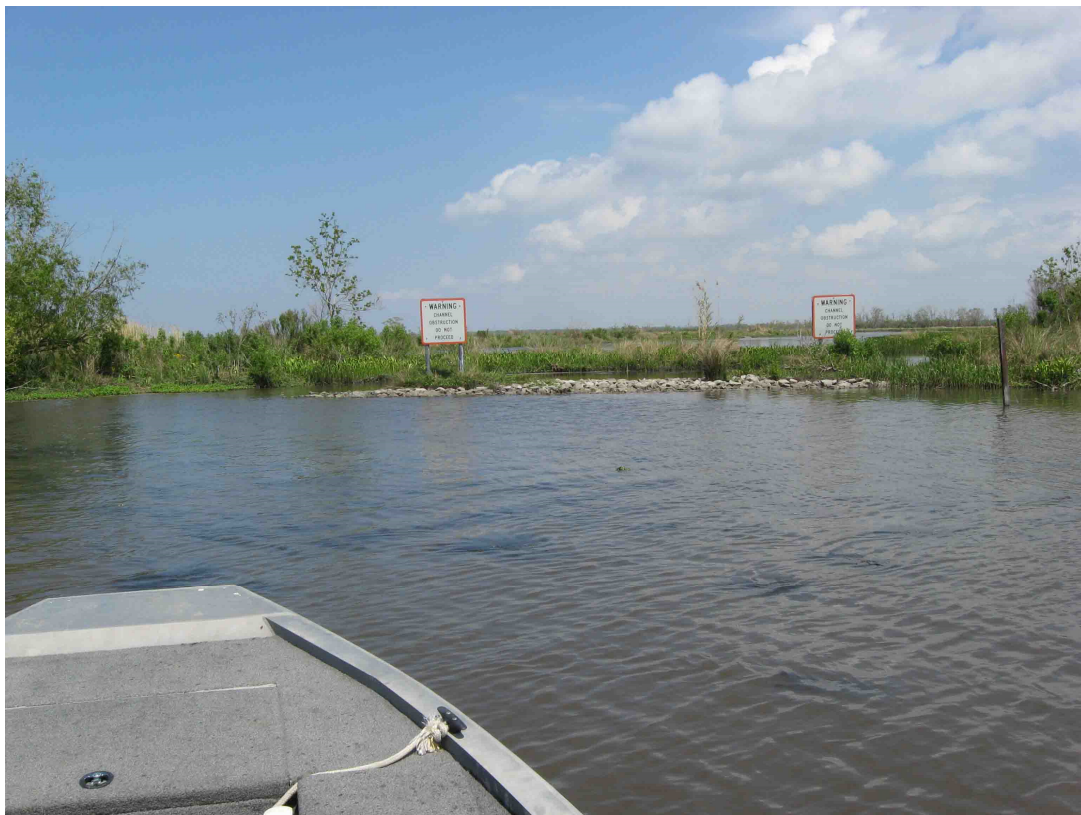
Upon a visual inspection, we noticed a large breach on the west side of the structure (Photo #2). Due to poor soil conditions, this structure has experienced significant settlement problems since the time it was constructed. Several attempts were made during construction to stabilize the structure by placing several lifts of rock, but the structure continued to settle. The maintenance work for this structure will be performed during the construction of Construction Unit 4 (CU 4).

Photo #2 – Structure #14 (Note Gap on Left)

- The repairs noted at each structure will be included in the plans for Construction Unit 4. The work to be done will be paid for using the construction funds for Construction Unit 4.

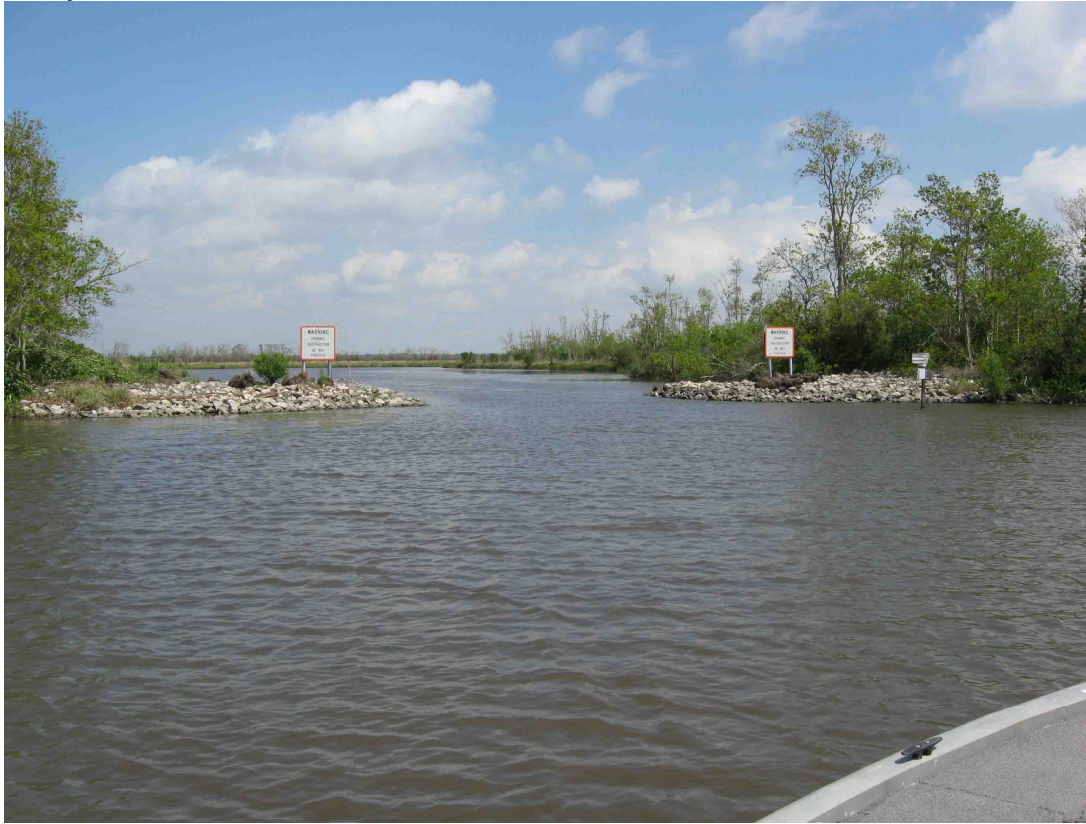
Photo #3 – Structure #15

Structure 15 appeared to be in good condition at the time of the inspection with little or no noticeable settlement of the rock weir (Photo #3). Signs and supports were also in good condition. The original design of this structure was modified to include a boat bay to accommodate oilfield activities and navigation on the interior marsh of the structure. During the construction of CU 4, this structure will be modified so that it represents the original design more accurately.

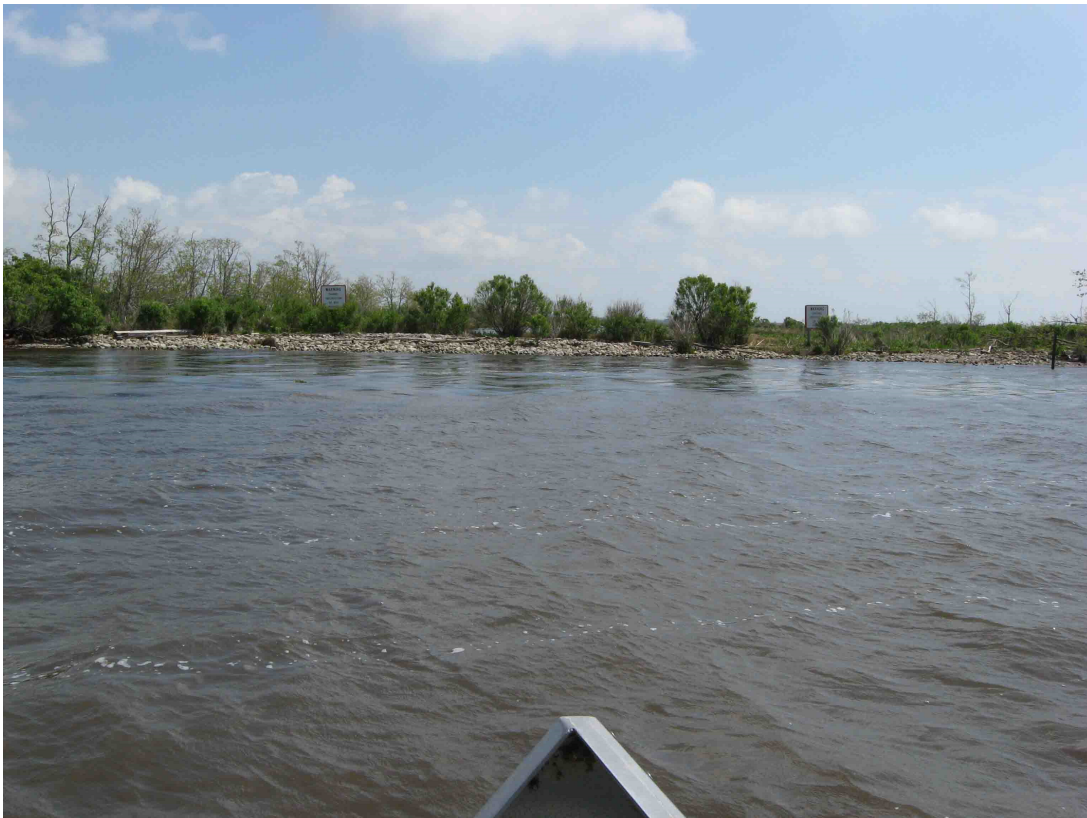
Photo #4 – Structure #17

During the inspection, we observed significant settlement near the warning sign on the south side of the structure and just east of the warning sign on the north side of the structure (Photo #4). The maintenance work for this structure will be performed during the construction of CU 4.

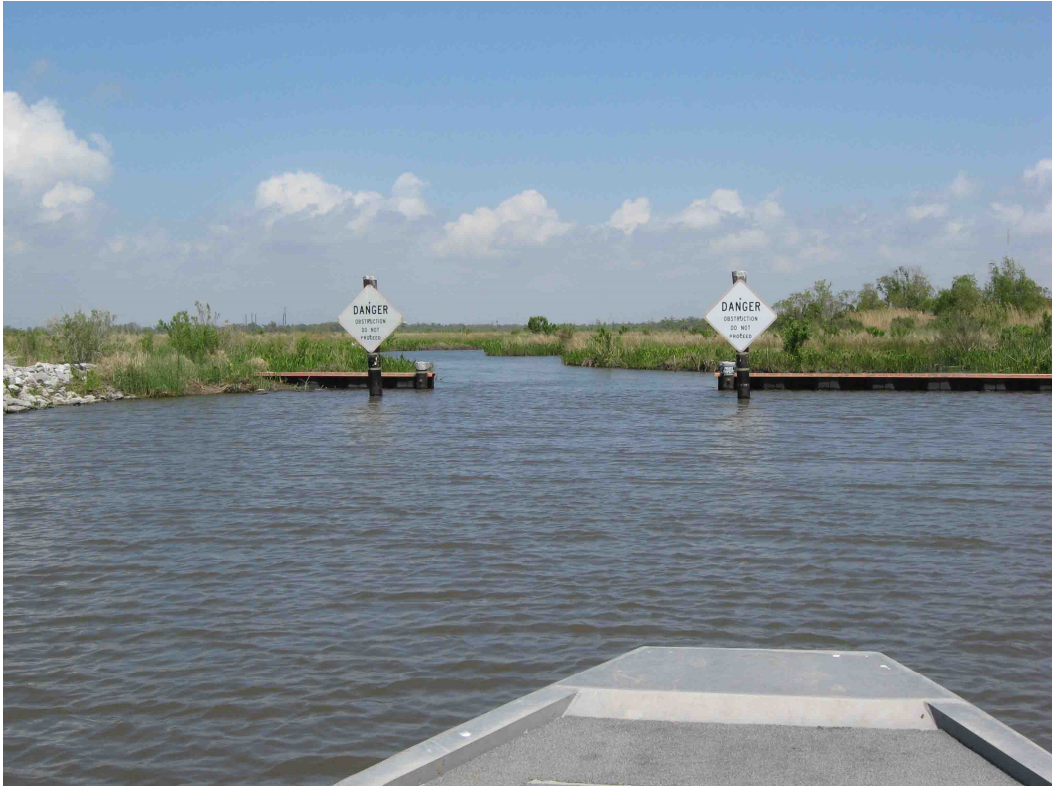
Photo #5 – Structure #22

The structure itself appears to be in good condition along with the signs, supports, and sheet pile caps (Photo #5). LDNR and NRCS agree that this structure will require no work at this time.

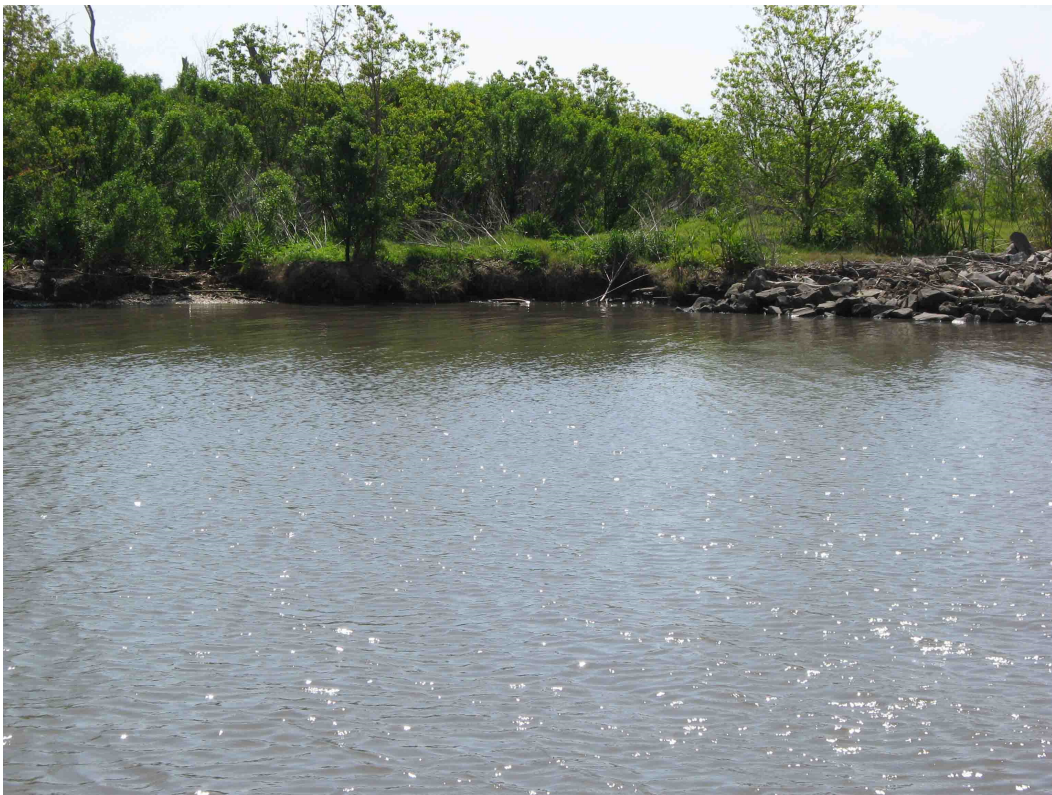
The Bayou Perot Bank Stabilization looks good. There was some erosion noticed at the western most portion of the West Reach of the structure (Photo #6). There was also some settlement noticed between Sta. 90+00 and 92+00. The maintenance work for this structure will be performed during the construction of CU4.

Overall this project has proven very effective in reducing shoreline erosion. With the exception of the few soft spots where the dike is experiencing more rapid settlement, the structure has proven very stable. The erosion at the end of Construction Unit 3 will continue to be monitored. The project features mentioned above will all be tied together with the construction of Construction Unit 4 which will provide a stronger, more stable shoreline protection system.

Photo #6 – West End of CU 3 (Note Errosion)
